LASER®

Viscous Fan Wrench Set - 2pc

Instructions

Viscous Fan Removal Tools - Land Rover

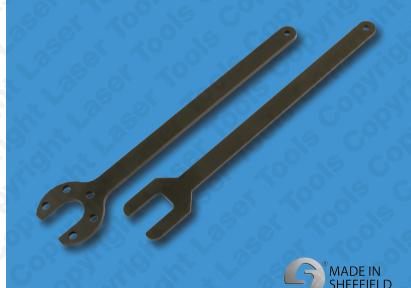
The set consists of 1 x 36mm open ended design flat wrench and 1 x 3 holed "horse shoe" design as shown.

The "horse shoe" shaped wrench is used to hold the viscous coupling still whilst the 36mm wrench is used to loosen or tighten the coupling.
